Re: Professional Traffic Engineering Services Existing Conditions Report Fox Hill Elementary School Burlington, Massachusetts Pare Project No. 23052.00

Pare Corporation (Pare) has completed an existing traffic conditions assessment for Fox Hill Elementary School in Burlington, MA. The Town of Burlington is pursuing the replacement of the existing Fox Hill Elementary School situated at the end of two roads: Fox Hill Road and Westwood Street. The new school will most likely be located on the same site and will continue to hold grades Kindergarten through Grade 5. There are currently approximately 480 students enrolled at the existing school. Due to the anticipated reduction in overall enrollment, two alternatives for the new school are currently under consideration, including:

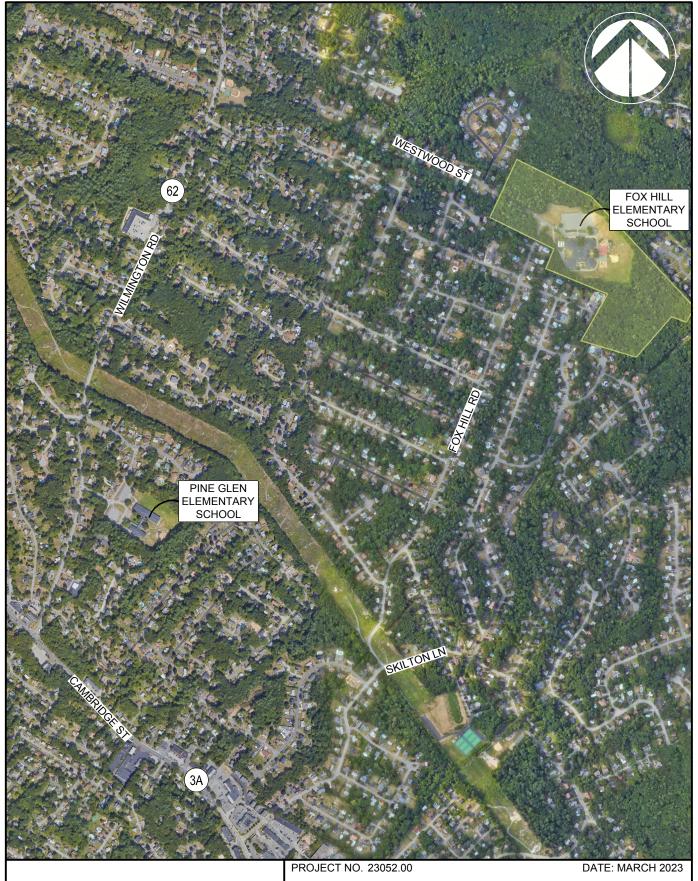
FIGURE 1 LOCUS MAP

A study area map, showing the location of the Fox Hill Elementary School and the surrounding area, is shown in Figure 1.

FOX HILL ELEMENTARY SCHOOL BURLINGTON, MA

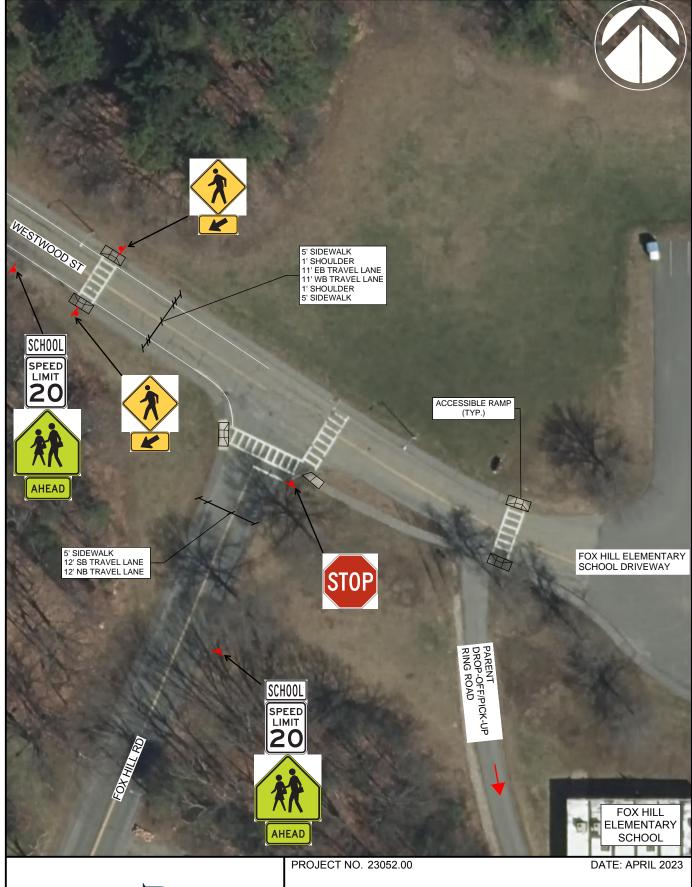
FIGURE 2
EXISTING ROADWAY CONDITIONS
FOX HILL ELEMENTARY SCHOOL
BURLINGTON, MA

The intersection of Fox Hill Road and Westwood Street is located only 150 feet from the school parking lot and, consequently, is integral to traffic operations on the school site. Fox Hill Road forms the south leg of the intersection, Westwood Street forms the west leg, and the school driveway forms the east leg. All approaches consist of a single travel lane. The northbound approach from Fox Hill Road is stop-controlled (with a stop sign) while the Westwood Road and school driveway approaches are uncontrolled. Crosswalks are striped across the south and east legs of the intersection. At the intersection, sidewalks are located along both sides of Westwood Street and the school driveway while sidewalk is only located on the west side of Fox Hill Road. **Figure 2** displays the existing intersection details.

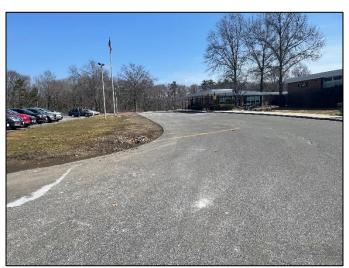
Photo 1: The front of Fox Hill Elementary School is used for bus drop-off/pick-up operations.

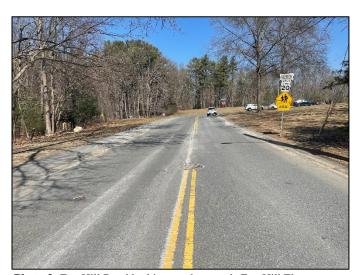
Fox Hill Road travels in the north/south direction, extending from Skilton Lane at its southern end to Westwood Street at its northern end. The roadway is typically 24 feet wide with a 12-foot travel lane in each direction. The travel lanes are divided by double-yellow striping. No white edge line is provided. A bituminous sidewalk is located along the west side of the roadway for its entire limits. The posted speed limit along most of the roadway 25 miles-per-hour. A school zone speed limit of 20 miles-per-hour is posted approximately 200' south of Westwood Street. **Photo 3** shows the cross section of Fox Hill Road approaching Fox Hill Elementary School. A series of speed bumps have been installed along Fox Hill Road spaced at intervals between 300'-500' in an effort to reduce vehicle speeds. **Photo 4** shows the typical speed bump with warning sign configuration on Fox Hill Road.

Photo 3: Fox Hill Road looking north towards Fox Hill Elementary School.

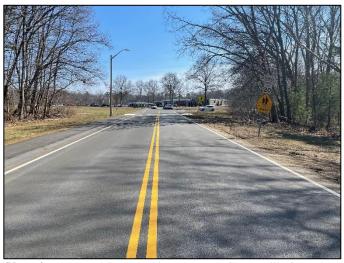
Westwood Street travels in the east/west direction extending from Wilmington Road (Rte. 62) at its western end to Fox Hill Road at its eastern end. The roadway is 24 feet wide with an 11-foot travel lane and a 1' shoulder in each direction. A bituminous sidewalk is installed along the north side of the roadway for its entire limits. The posted speed limit along Westwood Street is 30 miles-per-hour. A school zone speed limit of 20 miles-per-hour is posted approximately 150' west of Fox Hill Road. **Photo 2** shows the cross section of Westwood Street approaching Fox Hill Elementary School

Photo 2: Westwood Street looking east towards Fox Hill Elementary School.

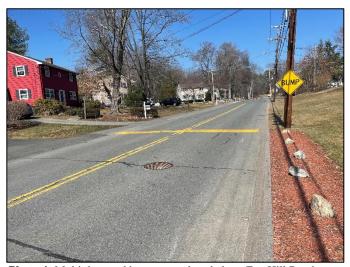
Photo 4: Multiple speed bumps are placed along Fox Hill Road south of Fox Hill Elementary School.

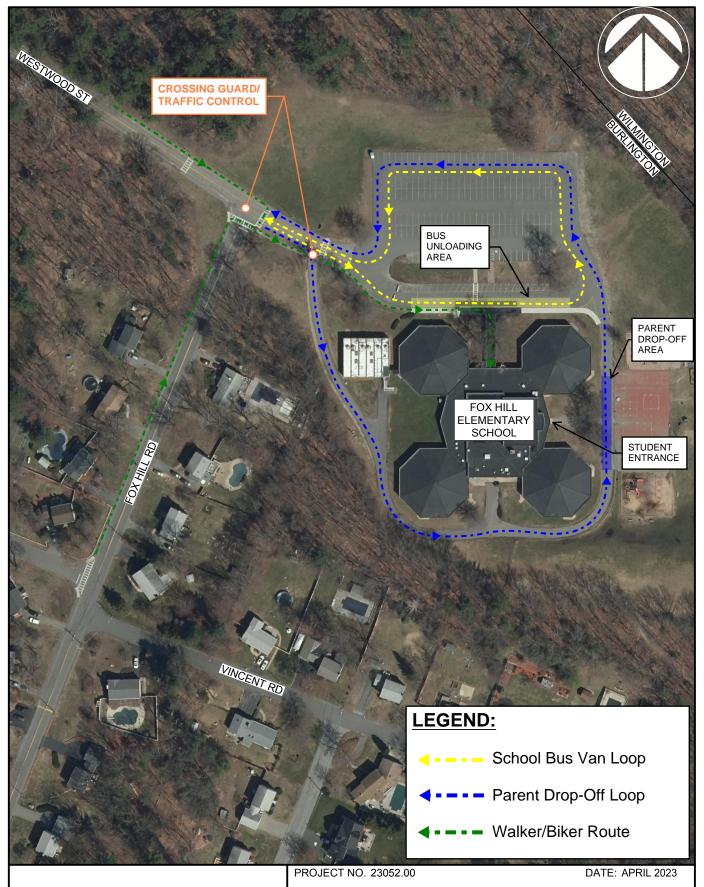
FIGURE 3
MORNING DROP-OFF CIRCULATION
FOX HILL ELEMENTARY SCHOOL
BURLINGTON, MA

A review of the existing traffic conditions at and around the school were completed through field observations conducted during school arrival and dismissal periods. Parking occupancy was also recorded in the school parking lot. All observations at the Fox Hill Elementary School were conducted on Wednesday, March 22, 2023, while the school was operating under typical conditions. The following describes the traffic operations observed at the school with supplemental photos providing additional details. Additionally, **Figure 3** graphically displays the arrival operations of the school.

The school day at Fox Hill Elementary School formally begins at 8:10 a.m. and Pare began morning arrival observations at approximately 7:30 a.m. During the morning arrival period, all traffic enters the site from the Fox Hill Road/Westwood Street intersection. School faculty and staff park in the site's parking lot. Bus drop-off occurs at the front of the building (**Photo 5**). A total of seven buses were observed, however, the bus arrival is sporadic and no more than two buses were observed unloading at the same time. Students are unloaded from the buses under the covered walkway and enter the school through the front entrance. Buses circulate around the perimeter of the parking lot and back to the main site driveway. Two buses were observed parking at the rear of the parking lot after unloading and waiting several minutes before exiting the site.

Parent traffic uses the ring road around the rear of the building for drop-off (**Photo 6**). The ring road is approximately 1,050' in length. A total of 84 parent vehicles used the ring road for drop-off. Drop-off occurs along the east side of the building (**Photo 7**). School staff are positioned along the vehicle unloading zone and assist students in exiting vehicles. Pare observed up to five vehicles unloading simultaneously. Students then walk from the unloading area into the eastern building entrance. Parent vehicles are then directed by signing and striping to exit the site by traveling through the outside parking lot aisle. A chain at the beginning of the ring road is used to restrict access to the rear of the building outside of the arrival period. Access to the ring road was closed at 8:08 a.m. by school staff (**Photo 8**). Twenty-four (24) parents were also observed parking in the parking lot to unload students. Parents would assist students in exiting the vehicle then walk the student to the front door where they were met by school staff.

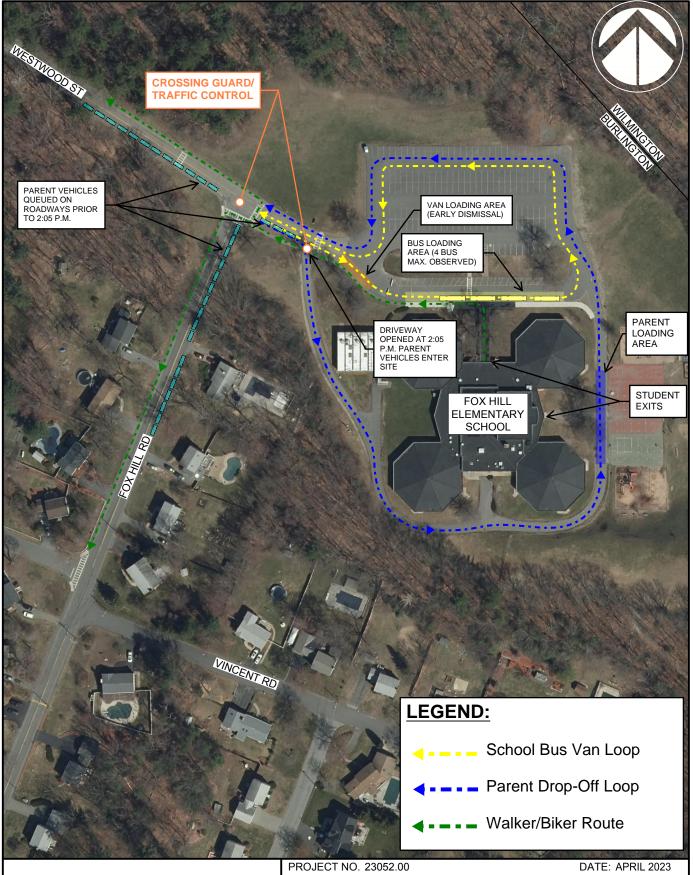
FIGURE 4

The afternoon dismissal procedure operates in a similar pattern to the morning arrival procedure. Pare first observed all four vans and approximately 5 parents picking up students at the northwest corner of the building, along the main site driveway. Students here were dismissed approximately 10-15 minutes early. These operations cleared prior to the full student dismissal at 2:10 p.m.

Parent traffic was observed beginning to queue along Fox Hill Road and Westwood Street well before the 2:10 p.m. dismissal. The rear ring road remained chained-off until 2:05 p.m. Pare observed a total of three parent vehicles queued adjacent to the ring road entrance (**Photo 11**), 12 parents vehicles queue along the south side of Westwood Street (**Photo 12**) and 17 parent vehicles queued along the east side of Fox Hill Road (**Photo 13**) before the chain was removed. Parent vehicles then filed into the ring road for student pick-up. A total of 44 parent vehicles used the loop for student pick-up. The maximum parent vehicle queue extended the entire limits of the ring road, approximately 1,050', resulting in one vehicle spilling into the main site driveway (**Photo 14**).

AFTERNOON PICK-UP CIRCULATION
FOX HILL ELEMENTARY SCHOOL
BURLINGTON, MA

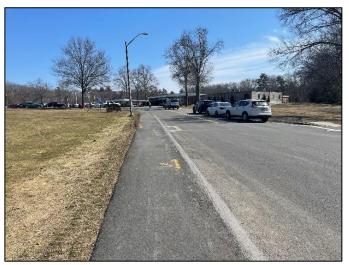
Photo 11: Parent vehicles queued at the entrance to the rear building ring road awaiting dismissal.

- Locate a parent vehicle queuing area on the site to eliminate the need for parents to queue within the existing travel lanes on Fox Hill Road and Westwood Road.
- Improve the sidewalk network in areas where it currently does not meet ADA standards.
- Provide school zone and student crosswalk signage and striping to meet current standards.

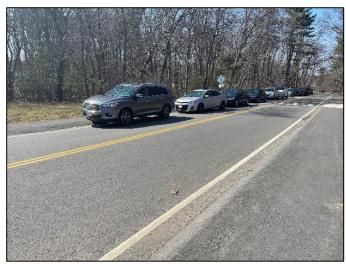
Photo 12: Parent vehicles queue along the south side of Westwood Street awaiting student dismissal.

- Pare observed that the stacking of parent vehicles along the Fox Hill Road/Westwood Street intersection approaches results in some traffic safety concerns. Specifically, neither roadway has the shoulder area to allow vehicles to pull outside the limits of the travel lane. This forces northbound vehicles on Fox Hill Road and eastbound vehicles on Westwood Street to occupy the oncoming travel lane when traversing the intersection. Additionally, the presence of queued vehicles (especially larger trucks or SUVs) along the intersection approaches limit sight lines as drivers approach the intersection. While this intersection is in an isolated section of Town with little vehicle traffic outside of that generated by the school, Pare did observe other through traffic in the area during this time.

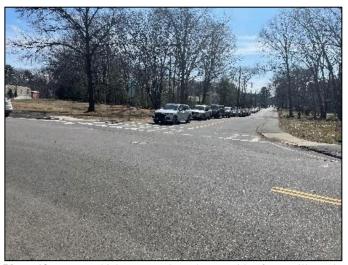
Photo 13: Parent vehicles queue along the east side of Fox Hill Road awaiting student dismissal.

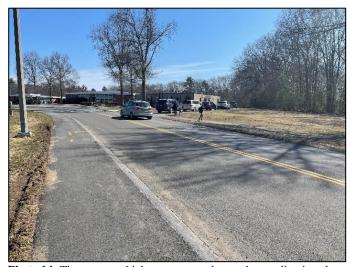
Photo 14: The parent vehicle queue was observed extending just the end of the rear building ring road.

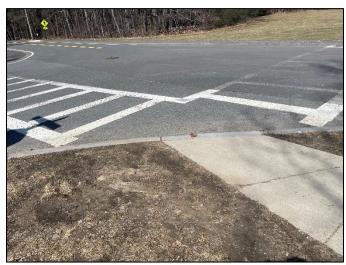
- The few students that were observed biking to/from school used the sidewalk on Westwood Street.
- None of the accessible sidewalk ramps within the site or at the intersection of Fox Hill Road and Westwood Street were accompanied by detectable warning panels. (**Photo 15**)

Photo 15: Accessible ramps lack detectable warning panels throughout the study area.

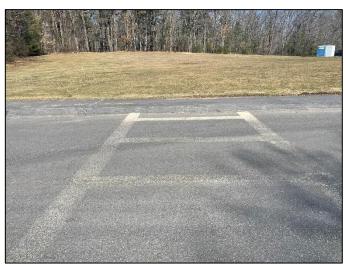
- There is no accessible ramp on the north side of the crosswalk across Westwood Street at Fox Hill Road. (**Photo 16**)
- Signing and striping at multiple locations through the site was faded making it illegible or difficult to read. (**Photo 17**)

Photo 16: There is not an accessible ramp at the north side of the crosswalk at Fox Hill Road and Westwood Street.

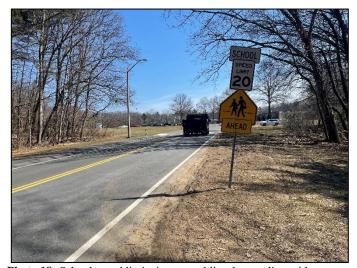
- The school zone and pedestrian crossing signage on Fox Hill Road and Westwood Street does not conform to the current Manual of Uniform Traffic Control (MUTCD) standards. (**Photo 18**)

Photo 18: School speed limit sign assemblies do not align with current standards.
